Survey Summary

Blue Panther s.r.o. Mezi vodami 29 143 00 Praha Ukázkový protokol 1. 12. 2020 10:04:14 1. 12. 2020 10:04:14

Ukázkový protokol z akustické Fluke ii910

Ukázkový protokol s prací s akustickou kamerou Fluke ii910

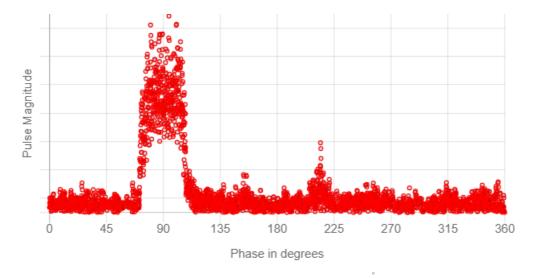
Discharge Analysis

File name	Default_0006.as2	
#	6	
Туре	🔁 PDQ	
Folder name	Default	
Date and time	1. 12. 2020 10:59:28	
Pulse count per minute	30303	
Discharge Type	External (Corona / Arcing):	100
	Internal:	0%
	Tracking:	0%
	Other:	0%

This plot is determined for a operating frequency of 50 Hz

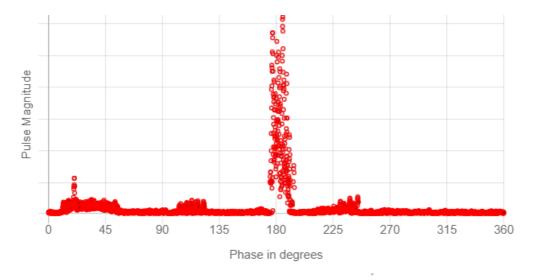
Discharge Analysis

File name #	Default_0007.as2 7	
Type Folder name Date and time	PDQ Default 1. 12. 2020 11:00:22	
Pulse count per minute	28271	
Discharge Type	External (Corona / Arcing):	87%
	Internal:	13%
	Tracking:	0%
	Other:	0%

This plot is determined for a operating frequency of 50 Hz
